Pump Lube Oil Reservoir Upgrade for a Petrochemical Customer

When a customer within the Petrochemical industry in Louisiana needed to upgrade their lube oil reservoir on a positive displacement pump, they enlisted the BSA team for support.

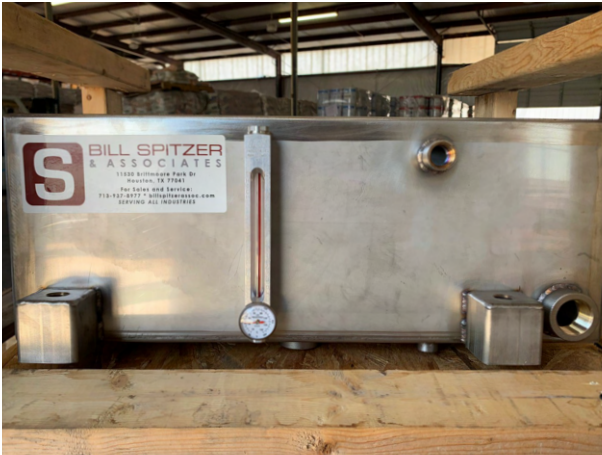
We started by increasing the original 4.5-gallon capacity to 10.1-gallons for increased production and efficiency. And we duplicated the pump flange and piping connections of the old reservoir to minimize field installation problems.

- Fabricated four threaded support brackets for adjustable legs
- Added a liquid level gauge with a thermometer
- Added a new drain connection with a crystal clear Luneta Tritan low point bowl assembly, that provides visual indication of any wear debris in the reservoir.

Everything was constructed from 304SS material - a significant improvement from the existing material of construction.

We not only increased the pump's capacity, but we also improved the pump's design with viewable temp and fluid level indication and added a low-point drain and contaminate-indicating sight glass. And we did all of this with some photos from a site visit - no design drawings to fabricate from.

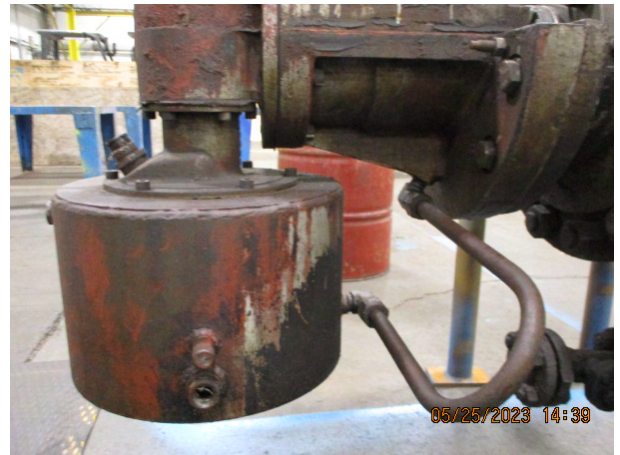
- More than doubled pump capacity
- Minimized field installation problems
- A way for the customer to easily identify any wear debris and check the fluid level in the reservoir without needing to take apart the pump
- Resumed operations in a tight turnaround
